Ariane 501 Inquiry Board report

ARIANE 5

Flight 501 Failure

Report by the Inquiry Board

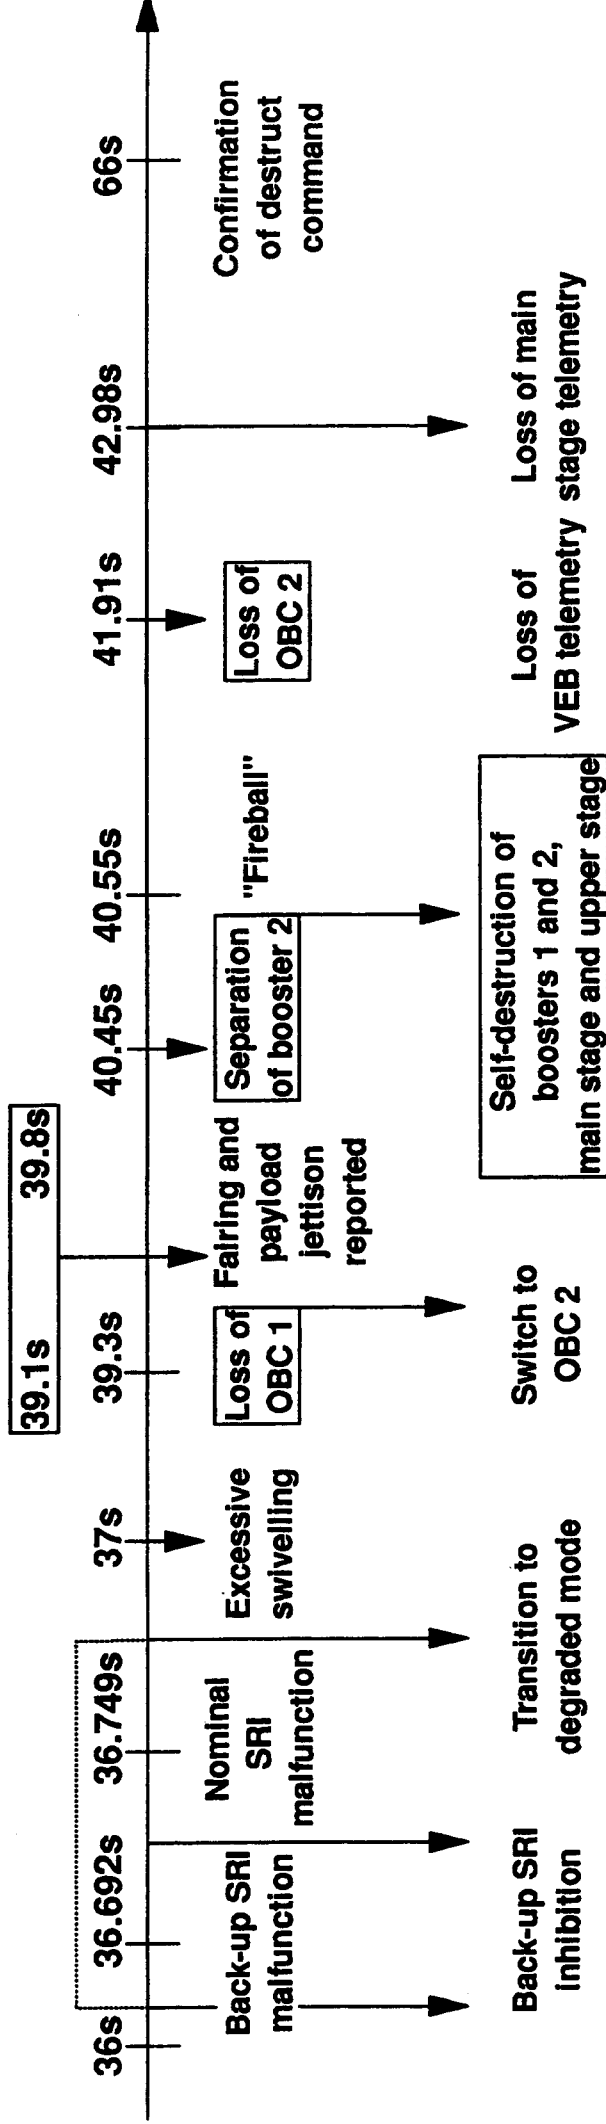
■ **Accident**

- **Back-up SRI malfunction detected (bit 9 = 0) in control cycle 552 (36.672 s)**
  - inhibition of back-up SRI (measurements no longer used)

- **Nominal SRI malfunction detected in control cycle 553 (36.744 s)**
  - double SRI malfunction
  - transition to degraded mode (viable only if last SRI active provides correct attitude data)

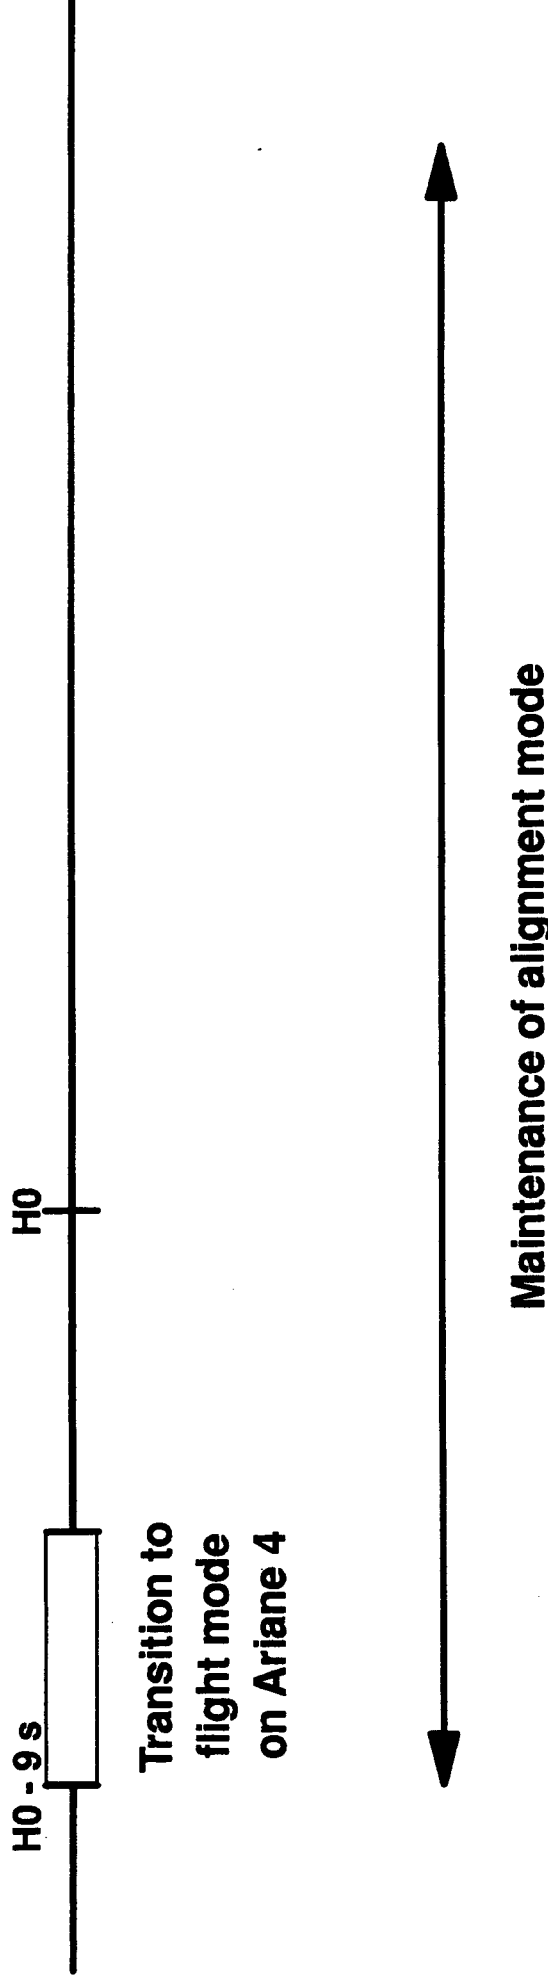
**The origin of the malfunction is connected with:**

- 1) Maintenance of alignment mode during first 50 seconds of flight, which corresponds to an Ariane 4 operational requirement and was retained on Ariane 5 as part of common Ariane 4 / Ariane 5 SRI development**

**2) The trajectory specific to Ariane 5, which, from H0 + 12 s, involved continuous tilting of the launcher with a much more pronounced pitch than Ariane 4**
