THE TACOMA NARROWS BRIDGE FAILURE

Revision A

By Tom Irvine
Email: tomirvine@aol.com

April 7, 2009

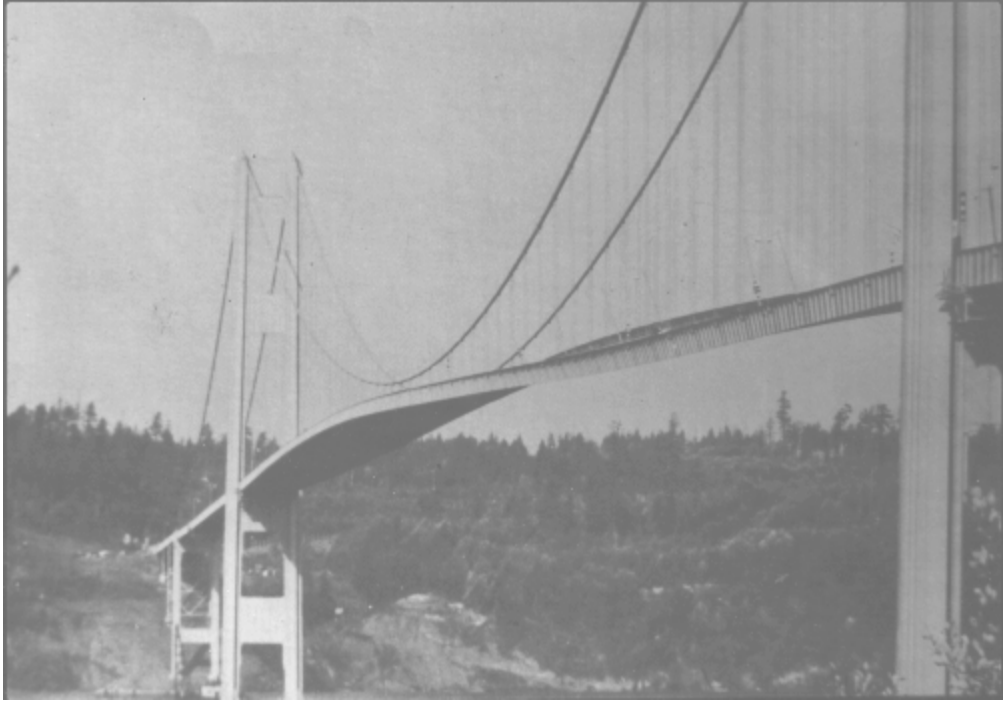
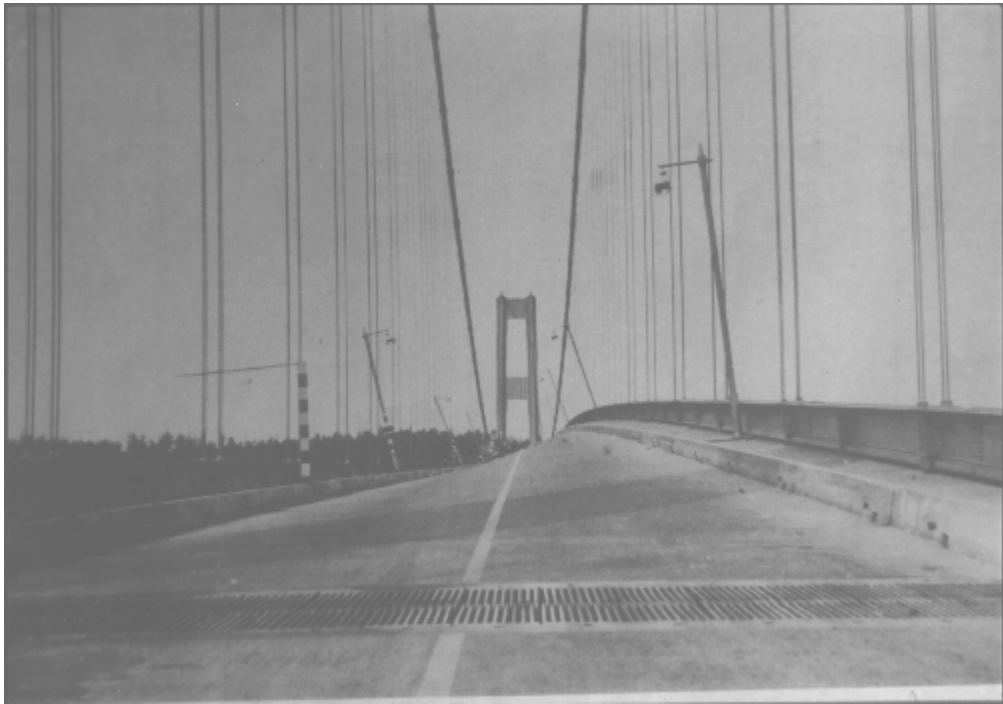
The wind then increased to 42 miles per hour. In addition, a support cable at mid-span snapped, resulting in an unbalanced loading condition. The bridge response thus changed to a 0.2 Hz torsional vibration mode, with an amplitude up to 28 feet. The torsional mode is shown in Figures 1a and 1b.

Figure 1a. Torsional Mode of the Tacoma Narrows Bridge

Figure 1b. Torsional Mode of the Tacoma Narrows Bridge

The torsional mode shape was such that the bridge was effectively divided into two halves. The two halves vibrated out-of-phase with one another. In other words, one half rotated clockwise, while the other rotated counter-clockwise. The two half spans then alternate polarities.

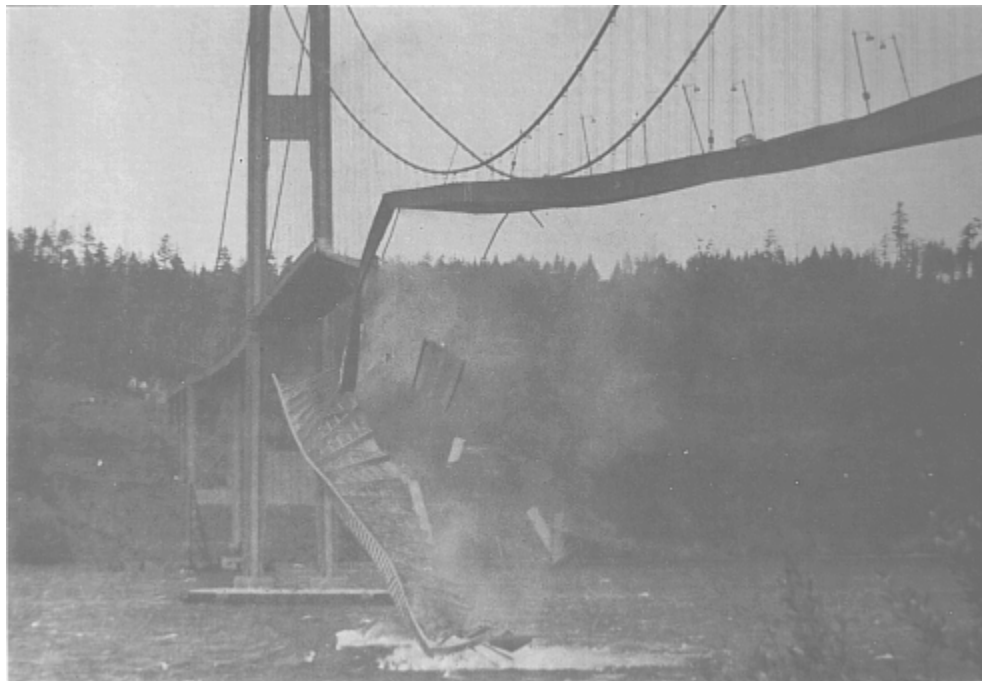
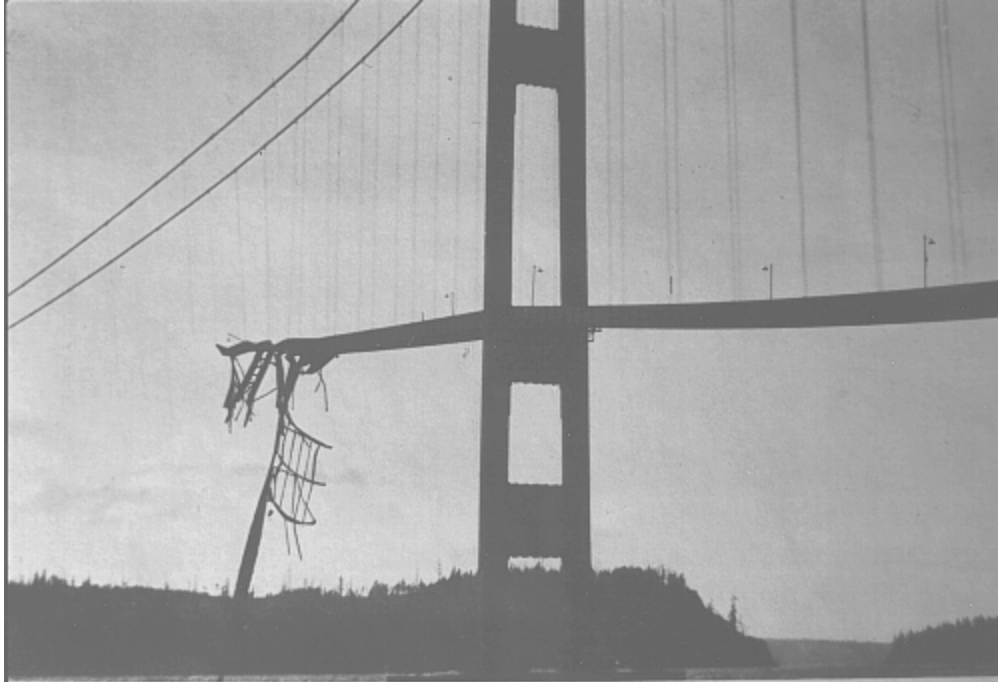
The bridge collapsed during the excitation of this torsional mode. Specifically, a 600 foot length of the center span broke loose from the suspenders and fell a distance of 190 feet into the cold waters below. The failure is shown in Figures 2a and 2b.

Figure 2a. Failure of the Tacoma Narrows Bridge

Figure 2b. Tacoma Narrows Bridge after the Failure

The fundamental weakness of the Tacoma Narrows Bridge was its extreme flexibility, both vertically and in torsion. This weakness was due to the shallowness of the stiffening girders and the narrowness of the roadway, relative to its span length.

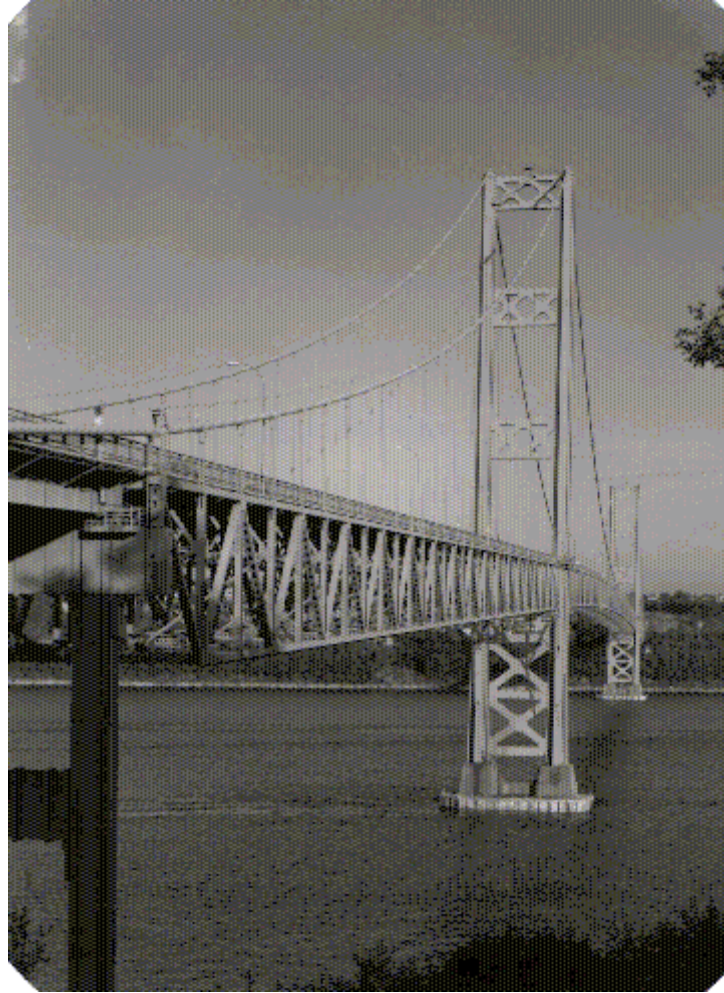
Figure 5. The Replacement Tacoma Narrows Bridge, Built in 1950

A new Tacoma Narrows Bridge was built in 1950, as shown in Figure 5. The second bridge had truss-girders which allowed the winds to pass through. It also had increased torsional stiffness because it was thicker and wider. Furthermore, wind tunnel testing was performed to verify the design of the new bridge prior to its construction.
