Abstract:**Type:**

Suspension bridge, Length: 1600 meters

On the morning of November 7th, 1940, a section of the Tacoma Narrows Bridge lay tangled in the west-side of the Puget Sound River. One of engineering's most fabled disasters unfolded that day revealing the errors in structural design that ultimately led to its dramatic collapse amid violent undulations.

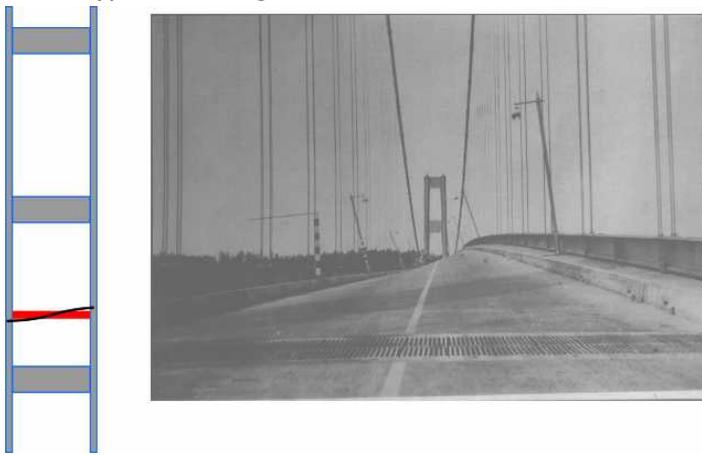
A new type of twisting

The failure of the bridge occurred when a new type of twisting occurred. This twisting, rather than longitudinal was torsional.

The left side would go down and the right side would rise and vice versa and the centreline of the bridge would remain steady. This is known as 'second torsional mode'

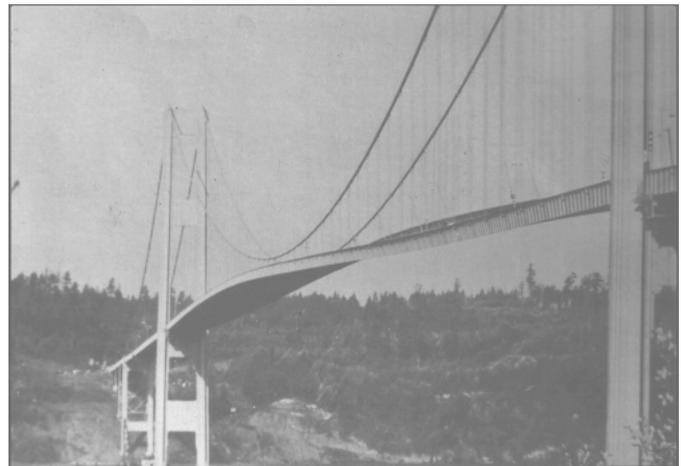
Anti Dampening (also known as positive feedback or self excitation)

- The bridge's angle of attack rose (exactly like a fin) thus giving more lift, twisting the deck even more until it aerodynamically stalls.
- The elastic energy stored in the deck returned the deck in the opposite direction.
- It now gets downwards lift and it continues to be pushed downwards until the deck stalls and the process is repeated.

BUT: With each cycle the amplitude increased because the wind added more energy than the work done in flexing the deck could dissipate. The ever increasing amplitude caused an overload to some of the suspender cables which critically weakened the bridge. Once a few of the cables broke, the weight of the deck could not be supported and it fell.

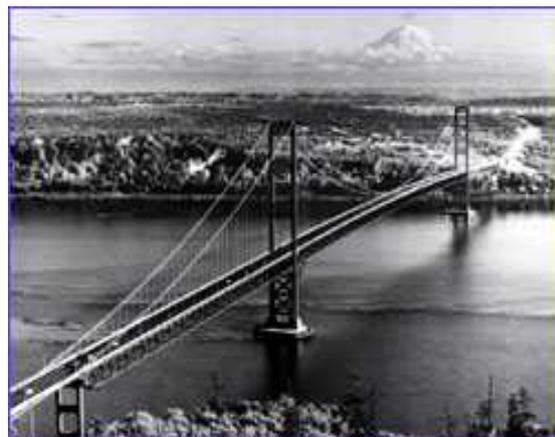
New Design

The new Tacoma Narrows Bridge was redesigned using a more robust open truss, stiffened trusses and openings in the roadbed to allow the wind to pass through. Engineers learned vast amounts because of this failure. Many of the unknown forces which act on suspension bridges were discovered and the suitable means to resist them. Wind tunnel analysis (and a better understanding of aerodynamics) has now become vital in designing modern day suspension bridges and other important information about such bridges behaviour has been closely examined with modern technology so as to not reproduce such a catastrophe.
