THE TACOMA NARROWS BRIDGE FAILURE

Revision A

By Tom Irvine
Email: tomirvine@aol.com

April 7, 2009

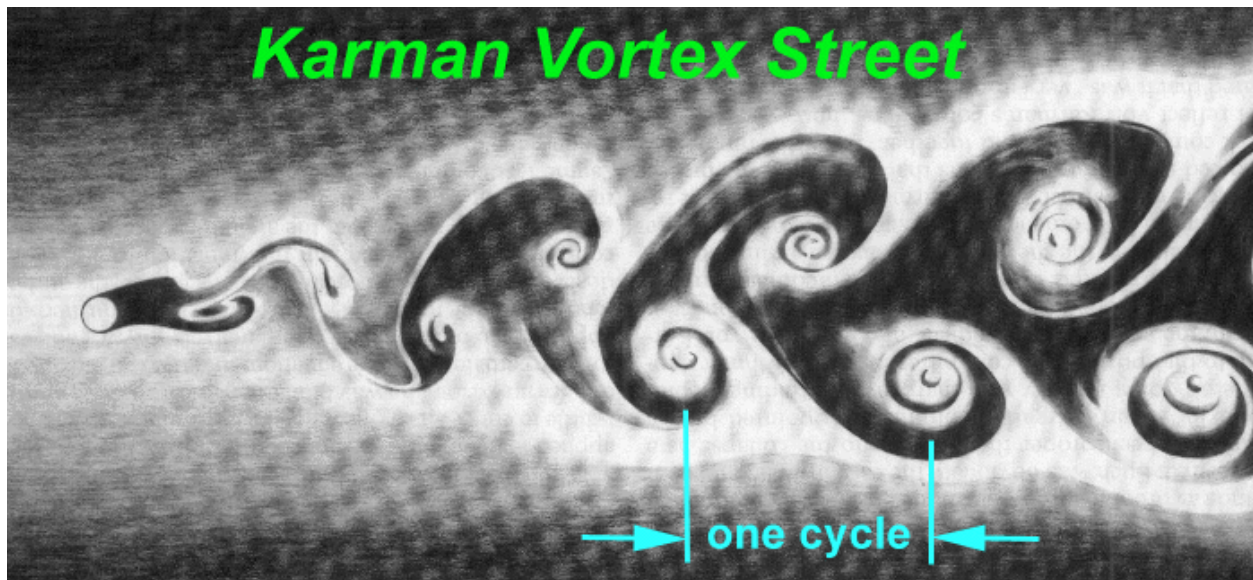
Figure 3. Vortex Shedding around a Spherical Body

Theodore von Karman, a famous aeronautical engineer, was convinced that vortex shedding drove the bridge oscillations. A diagram of vortex shedding around a spherical body is shown in Figure 3. Von Karman showed that blunt bodies such as bridge decks could also shed periodic vortices in their wakes.

A problem with this theory is that the natural vortex shedding frequency was calculated to be 1 Hz. This frequency is also called the "Strouhal frequency." The torsional mode frequency, however, was 0.2 Hz. This frequency was observed by Professor F. B. Farquharson, who witnessed the collapse of the bridge. The calculated vortex shedding frequency was five times higher than the torsional frequency. It was thus too high to have excited the torsional mode frequency. Further information is given in Appendix A.

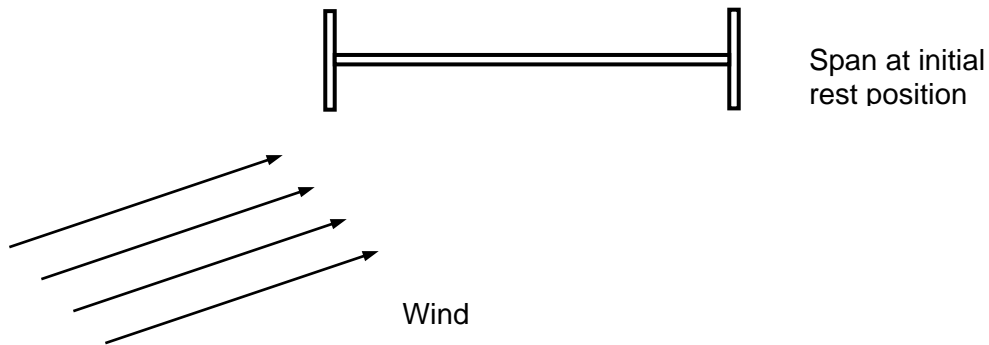
Figure 4a.

Assume that the wind direction was not perfectly horizontal, perhaps striking the bridge span from below, as shown in Figure 4a

Thus, the bridge is initially at an angle-of-attack with respect to the wind. Aerodynamic lift is generated because the pressure below the span is greater than the pressure above. This lift force effectively places a torque, or moment, on the bridge. The span then begins to twist clockwise as show in Figure 4b. Specifically, the windward edge rotates upward while the leeward edge rotates downward.

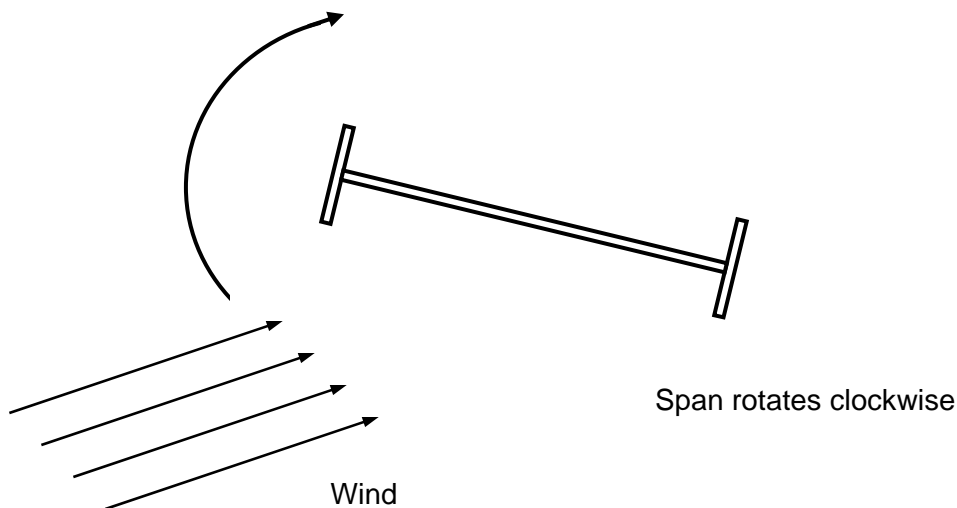
Figure 4b.

The span has rotational stiffness, however. Thus, elastic strain energy builds up as the span rotates. Eventually, the stiffness moment overcomes the moment from the lift force. The span then reverses its course, now rotating counter-clockwise

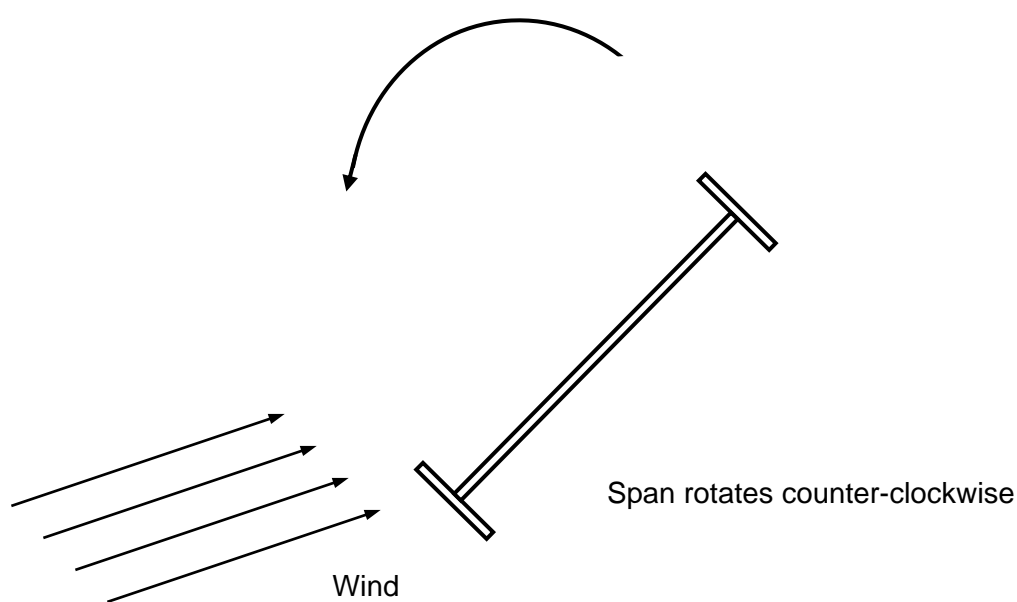
The span's angular momentum will not allow it to simply return to its initial rest position, however. The reason is that there is little or no energy dissipation mechanism. Thus, the span overshoots its initial rest position. In fact, it overshoots to the extent that the wind now strikes the span from above as shown in Figure 4c. The wind's lift force now effectively places a counter-clockwise moment on the span.

Once again, strain energy builds up in the span material. Eventually, the stiffness moment exceeds the moment from the wind's lift force. The span thus reverse course, now rotating clockwise. Again, it overshoots its rest position. The cycle of oscillation begins anew from the position shown in Figure 4a, except that the span now has rotational velocity as it passes through the original rest position.

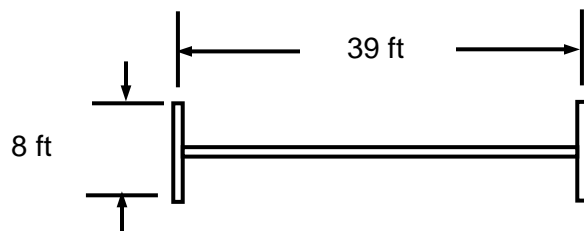
Figure A-1. Cross-section of Tacoma Narrows Bridge Span

The fundamental weakness of the Tacoma Narrows Bridge was its extreme flexibility, both vertically and in torsion. This weakness was due to the shallowness of the stiffening girders and the narrowness of the roadway, relative to its span length.

A cross-section of the bridge is shown in Figure A-1.

The Strouhal number for the bridge cross-section is $S = 0.11$ according to Reference 5. Furthermore, the characteristic dimension is the girder height 8 ft. The Strouhal frequency for a 42 mph (61.6 ft/sec) wind is thus
